**TEST REPORT ON INFRARED
WARNING RECEIVER (IRWR) FLIGHT
VIBRATION MEASUREMENTS**

REPORT NO: AFWAL/FIBG/79-10

TYPE OF TEST: Airborne Vibration Measurements

This test report presents data which define the vibration environments experienced by two infrared warning receiver (IRWR) units mounted on the HH-53 helicopter and the C-130E transport aircraft.

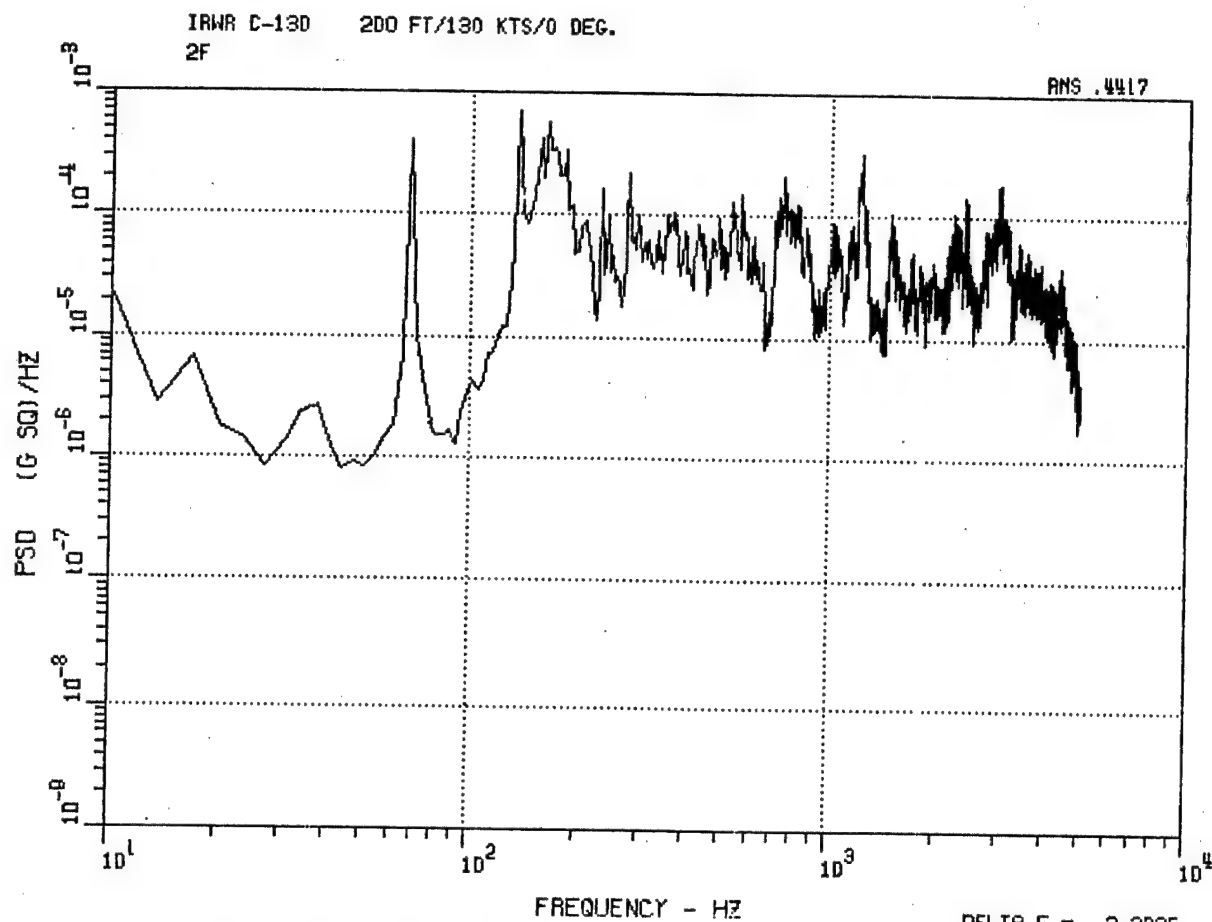
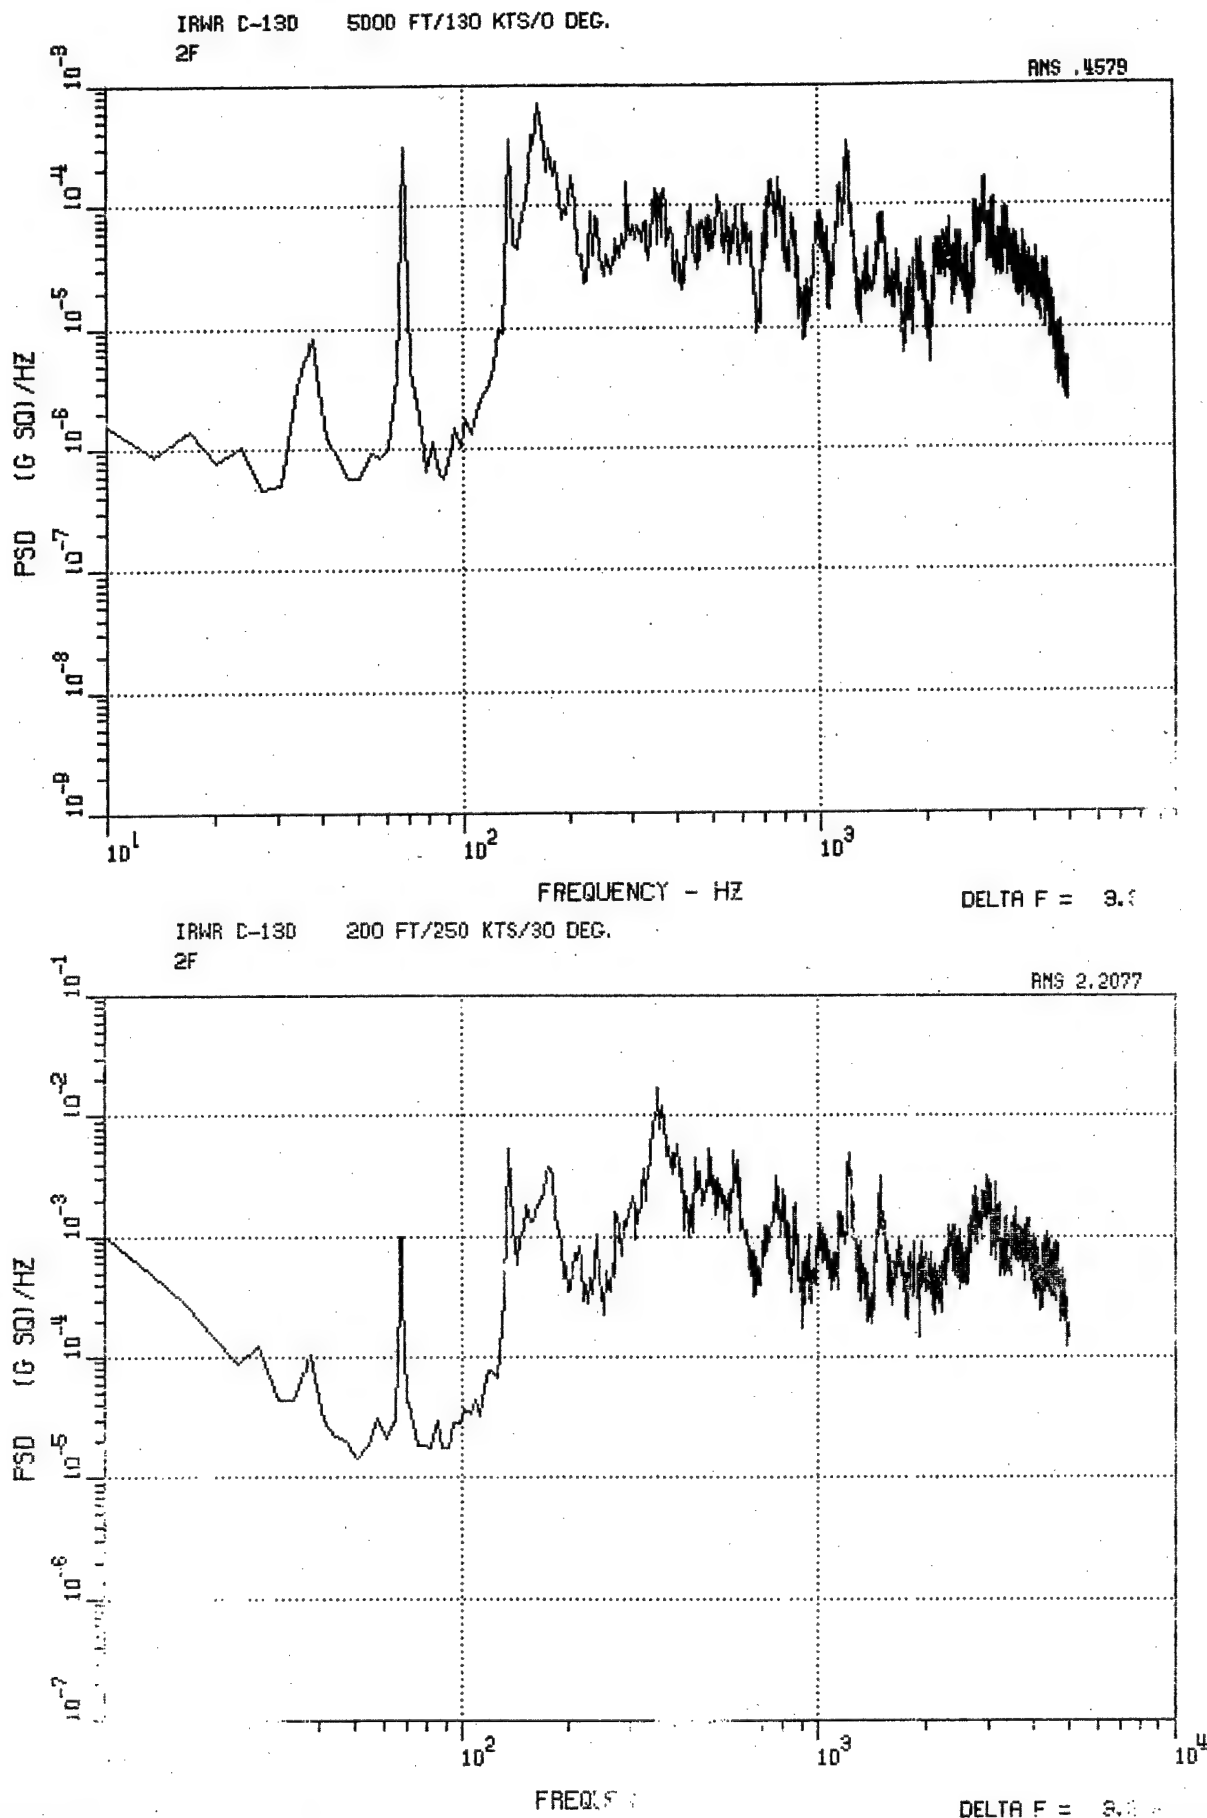
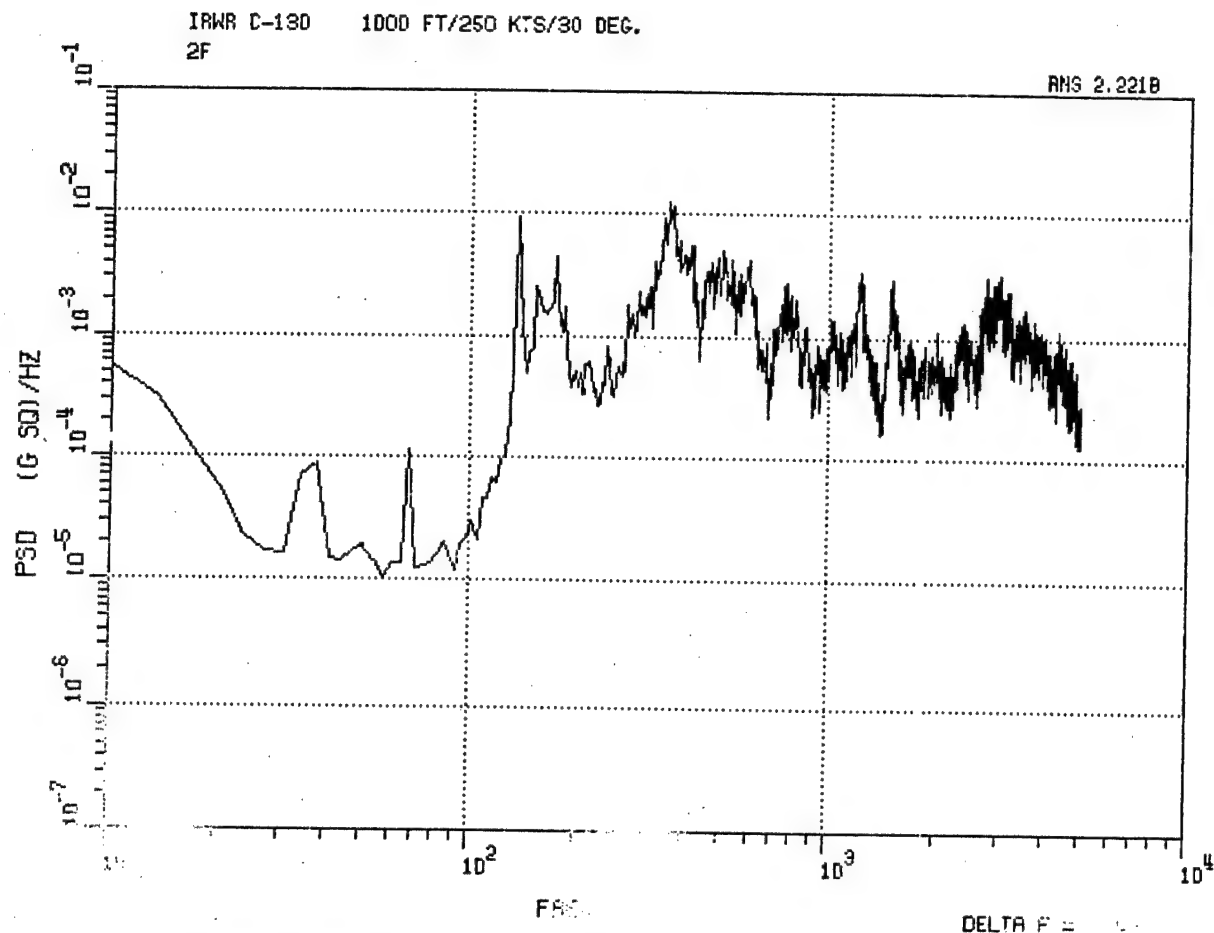
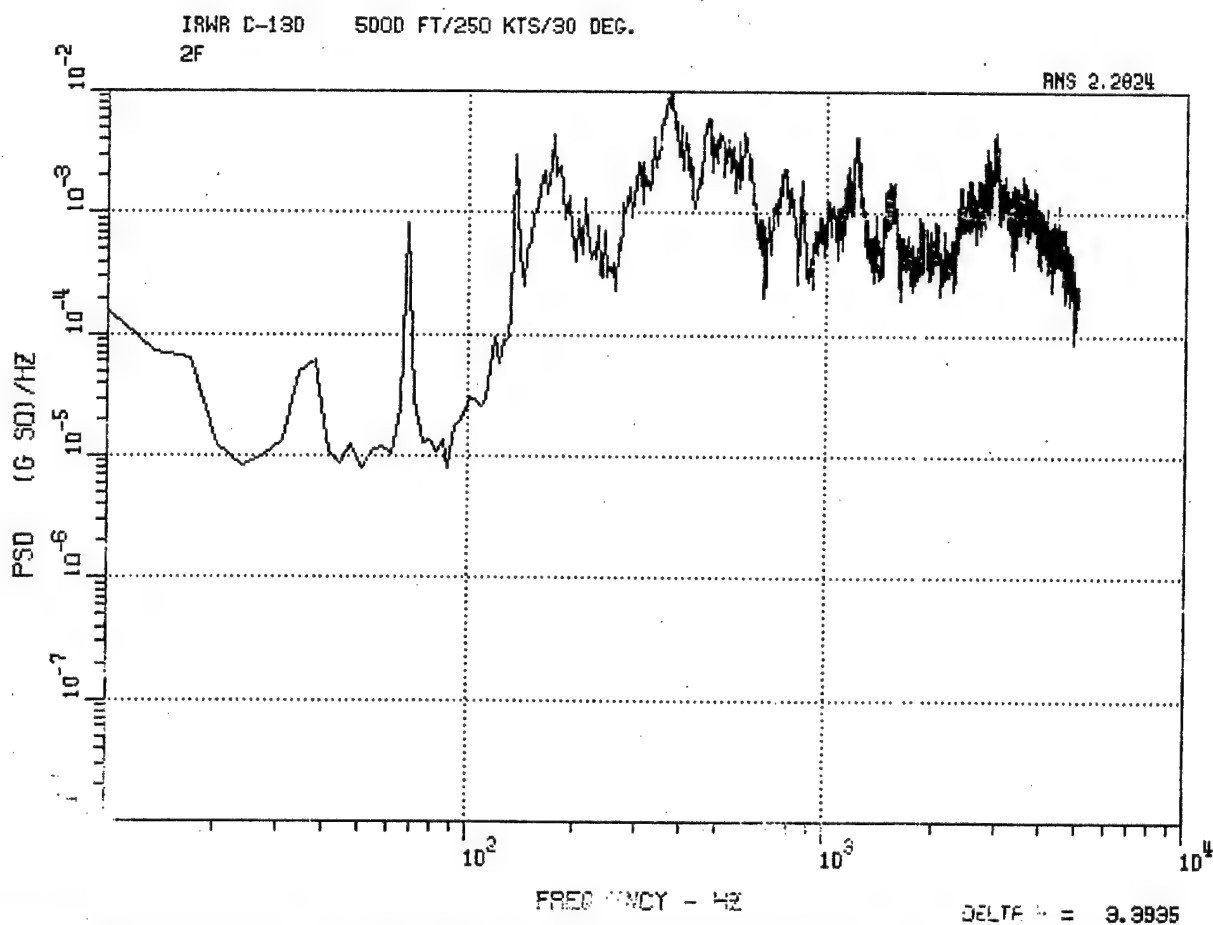
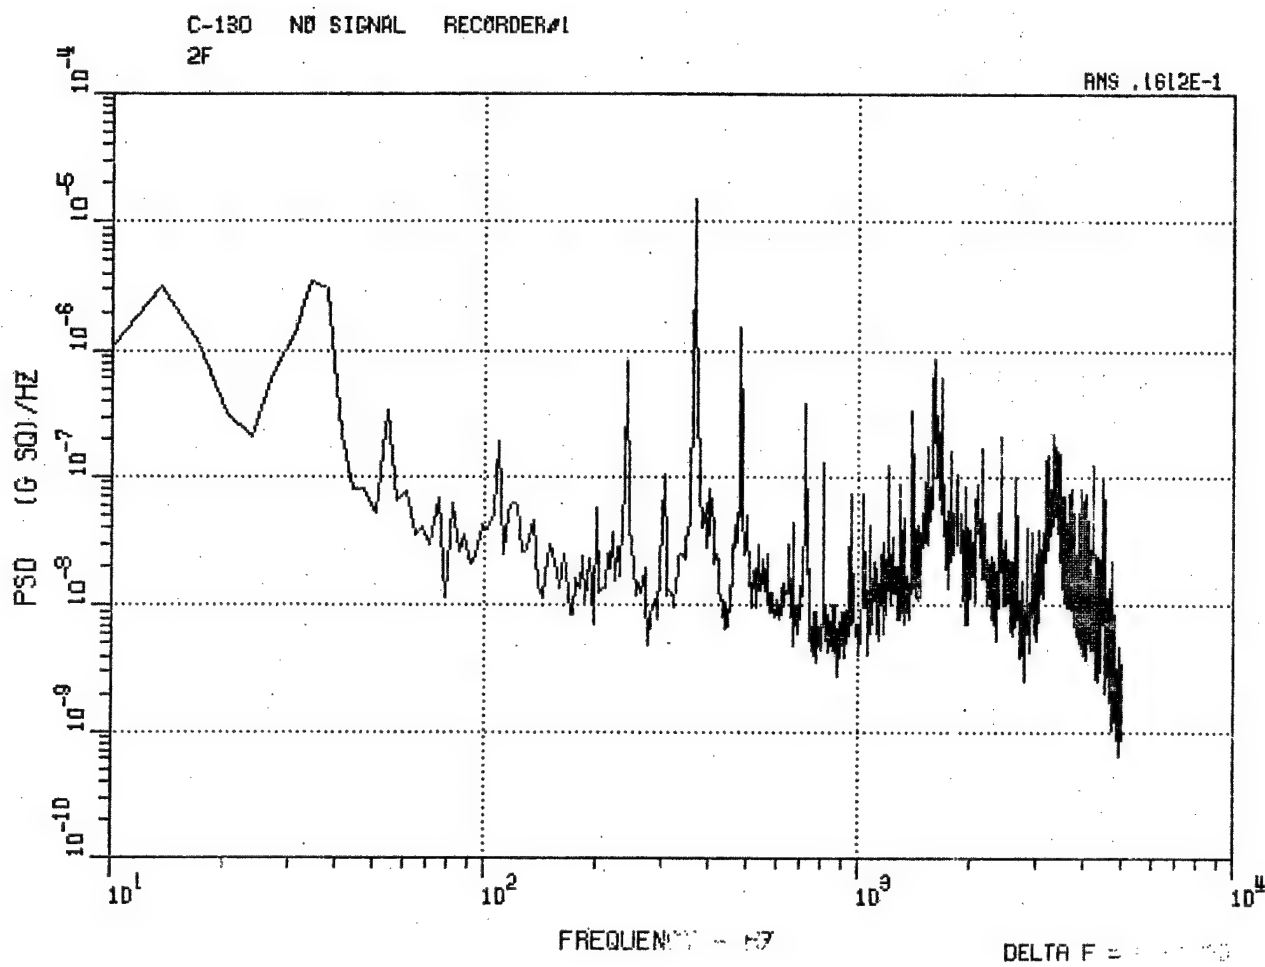
Figure 12. C-130 Fwd Lateral Accelerometer 2F,
200 Ft, 130 Kt, 0 Deg, and 1000 Ft,
130 Kt, 0 Deg.

Figure 13. C-130 Fwd Lateral Accelerometer 2F, 5000 Ft, 130 Kt, 0 Deg, and 200 Ft, 250 Kt, 30 Deg.

Figure 14. C-130 Fwd Lateral Accelerometer 2F, 1000 Ft, 250 Kt, 30 Deg, and 5000 Ft, 250 Kt, 30 Deg.

Figure 15. C-130 Fwd Lateral Accelerometer 2F,
No-Signal Record.

The C-130 spectra are shown in Figures 12-59. Figures 12-15 show the lateral accelerometer 2F on the forward left AAR-43 for the six flight conditions and for the no-signal condition. This last condition is with instrument power on but with the aircraft engines turned off. It gives a measure of the noise in the instrumentation system. Of particular concern is the 400-Hz electrical supply frequency, which may sometimes be seen in the vibration data. Each of the data plots in this report should be compared with the corresponding no-signal record to determine the validity of individual spectral lines.

The lateral vibration of accelerometer 2F during the low-speed flight conditions (130 Kts) has a very low spectral density below 50 Hz. At 68 Hz there is a major peak corresponding to a propeller blade-passage frequency of 4100 rpm. Above 200 Hz, the spectrum is essentially flat at $10^{-4} \text{ g}^2/\text{Hz}$. For the higher speed flight (250 Kts), the entire spectrum is raised an order of

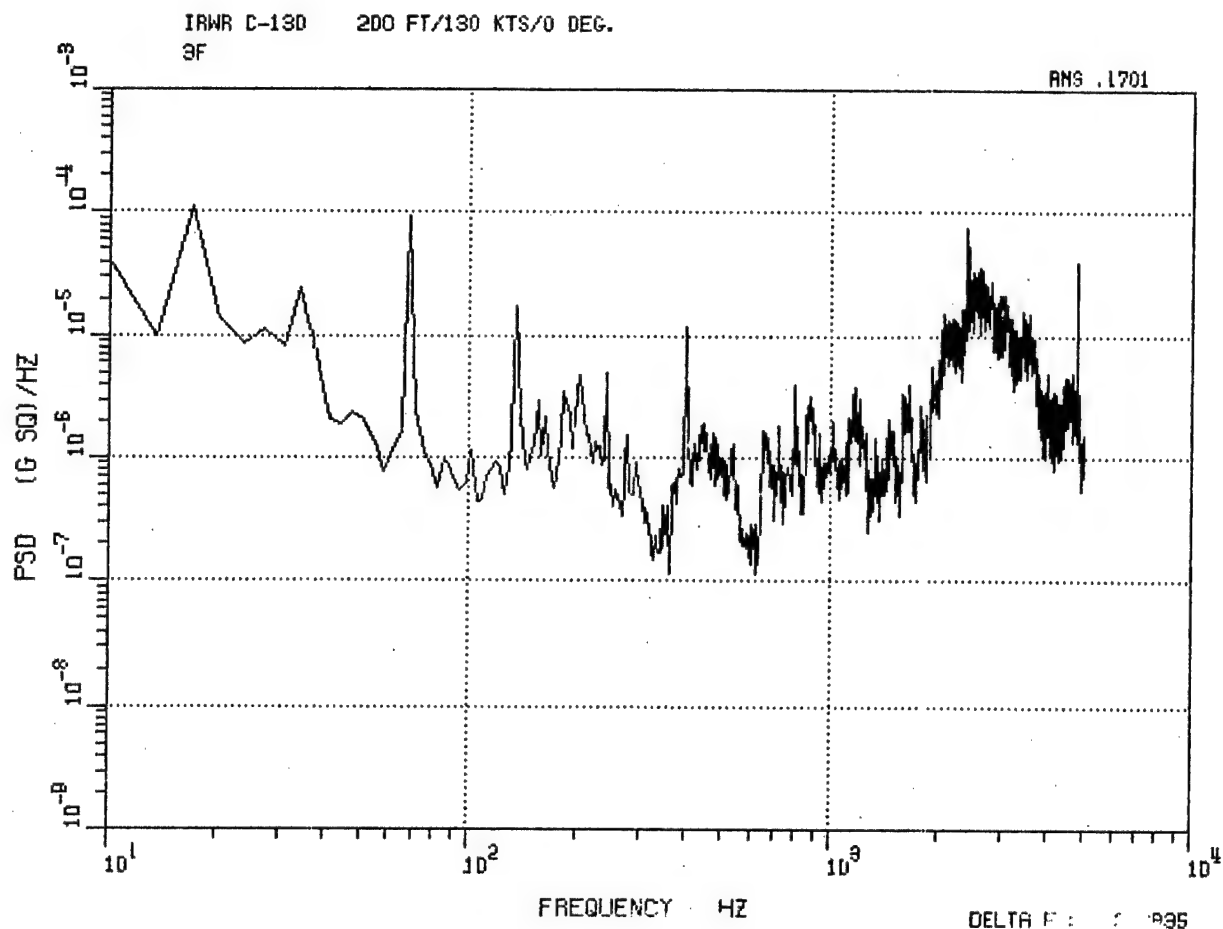
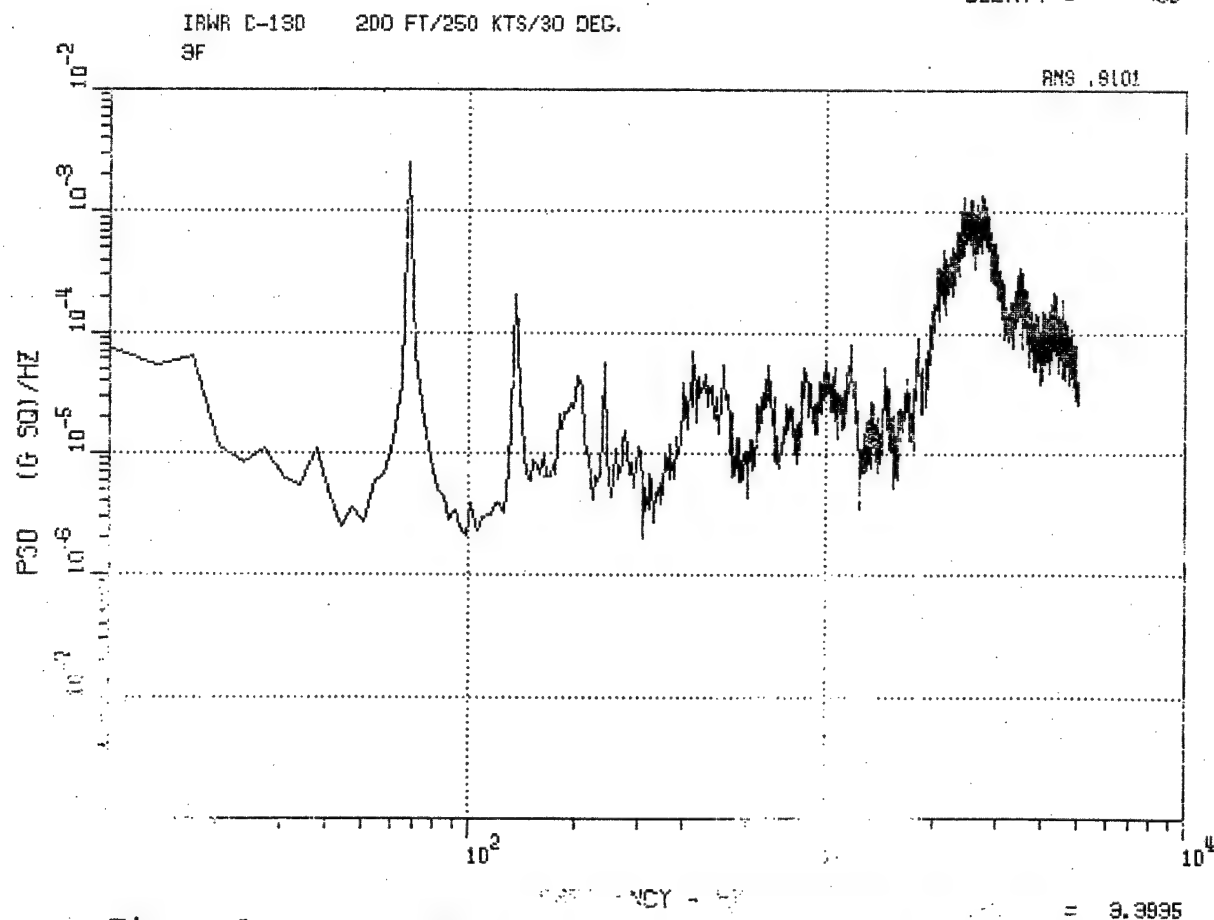
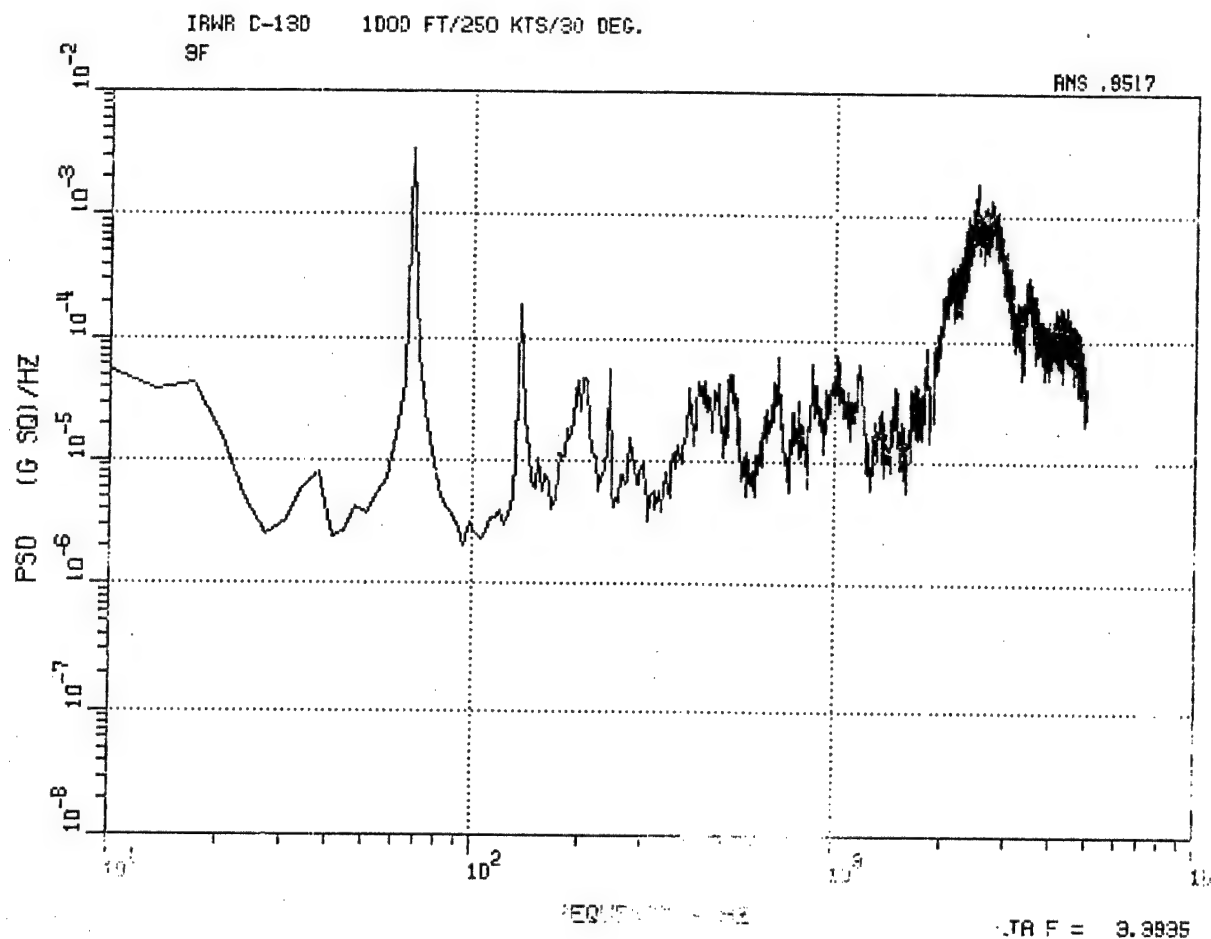
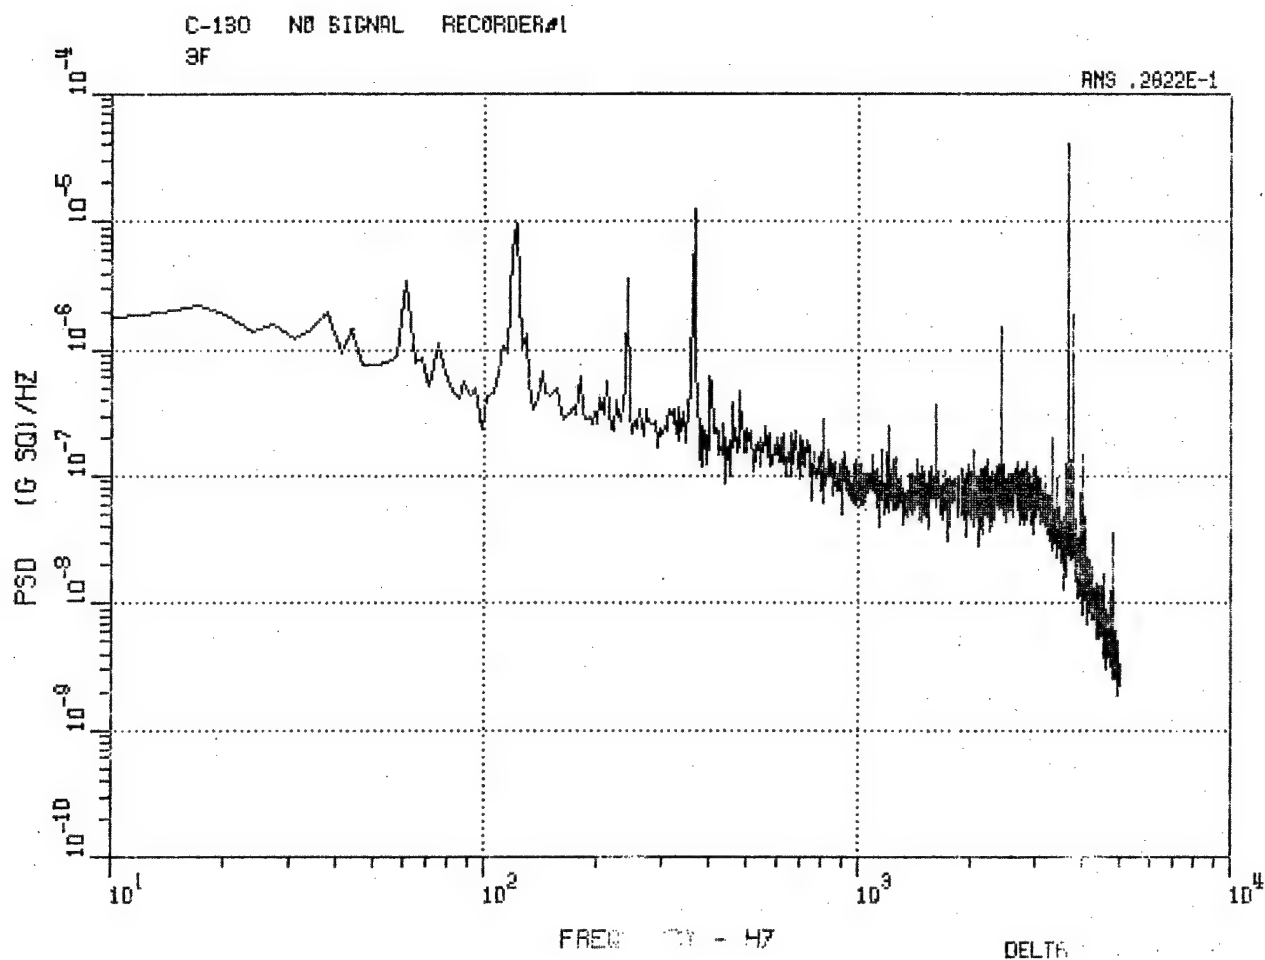
Figure 16. C-130 Fwd Vertical Accelerometer 3F, 200 Ft, 130 Kt, 0 Deg, and 1000 Ft, 130 Kt, 0 Deg.

Figure 17. C-130 Fwd Vertical Accelerometer 3F, 5000 Ft, 130 Kt, 0 Deg, and 200 Ft, 250 Kt, 30 Deg.

Figure 18. C-130 Fwd Vertical Accelerometer 3F, 1000 Ft, 250 Kt, 30 Deg, and 5000 Ft, 250 Kt, 30 Deg.

Figure 19. C-130 Fwd Vertical Accelerometer 3F,
No-Signal Record.

The vertical acceleration is much lower than the lateral, as shown for Sensor 3F in Figures 16-19. The longitudinal vibration, shown for Sensor 6F in Figures 20-23, is lower still, and is dominated at the higher frequencies by several discrete blade-passage frequencies and overtones. The forward microphone, MF, plotted in Figures 24-27, shows fairly low overall sound-pressure levels. The 400-Hz peak in the microphone data is probably instrument noise. The higher speed flight conditions add about 10 dB to the noise levels at the forward AAR-43 location.

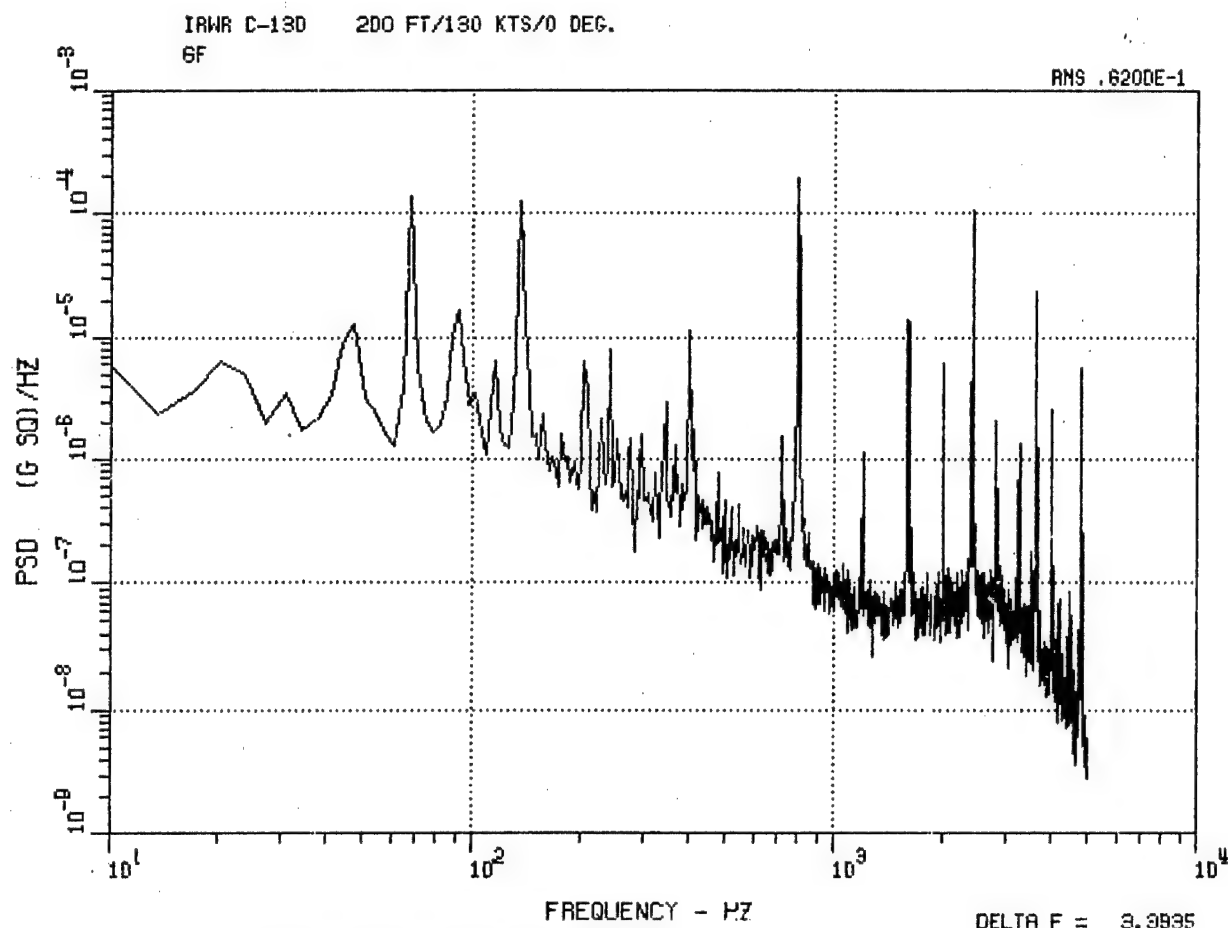
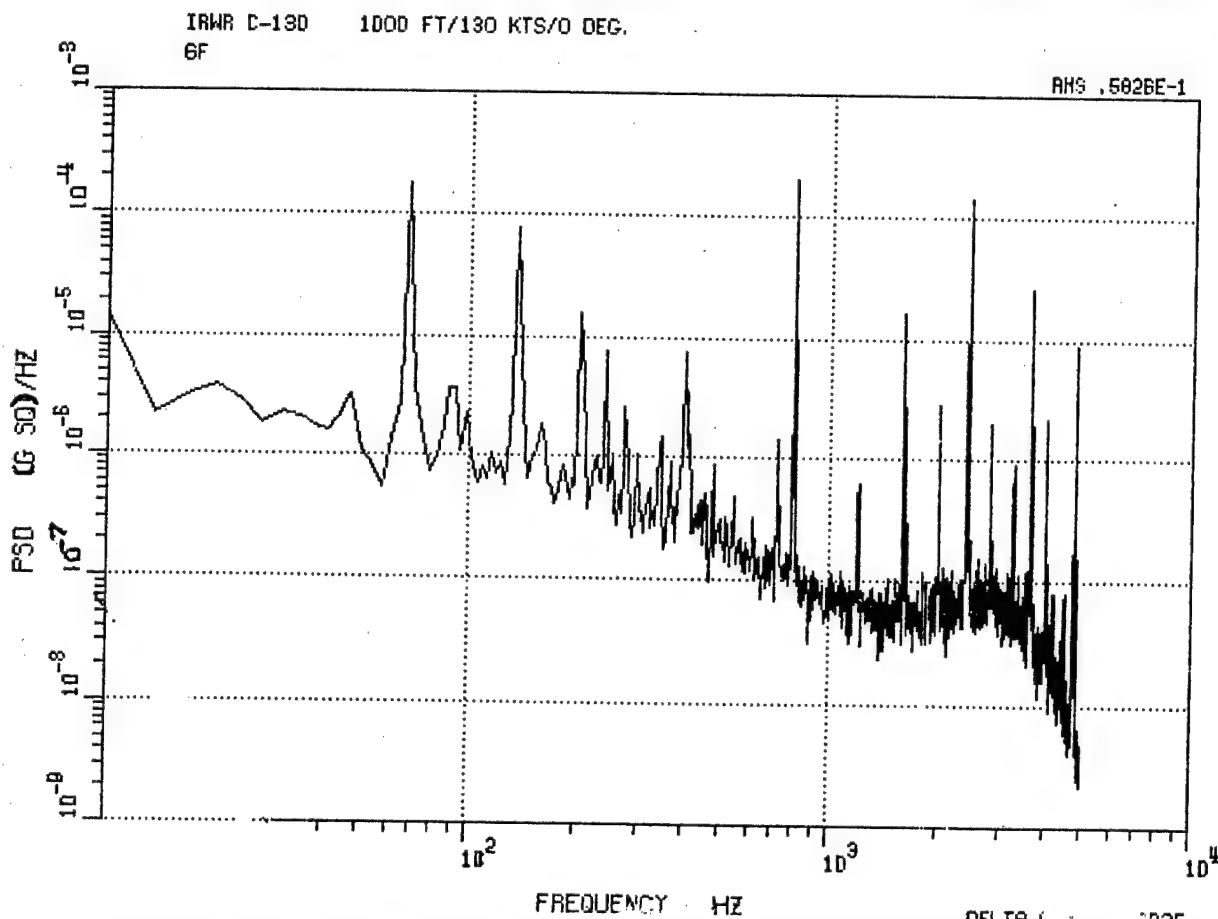
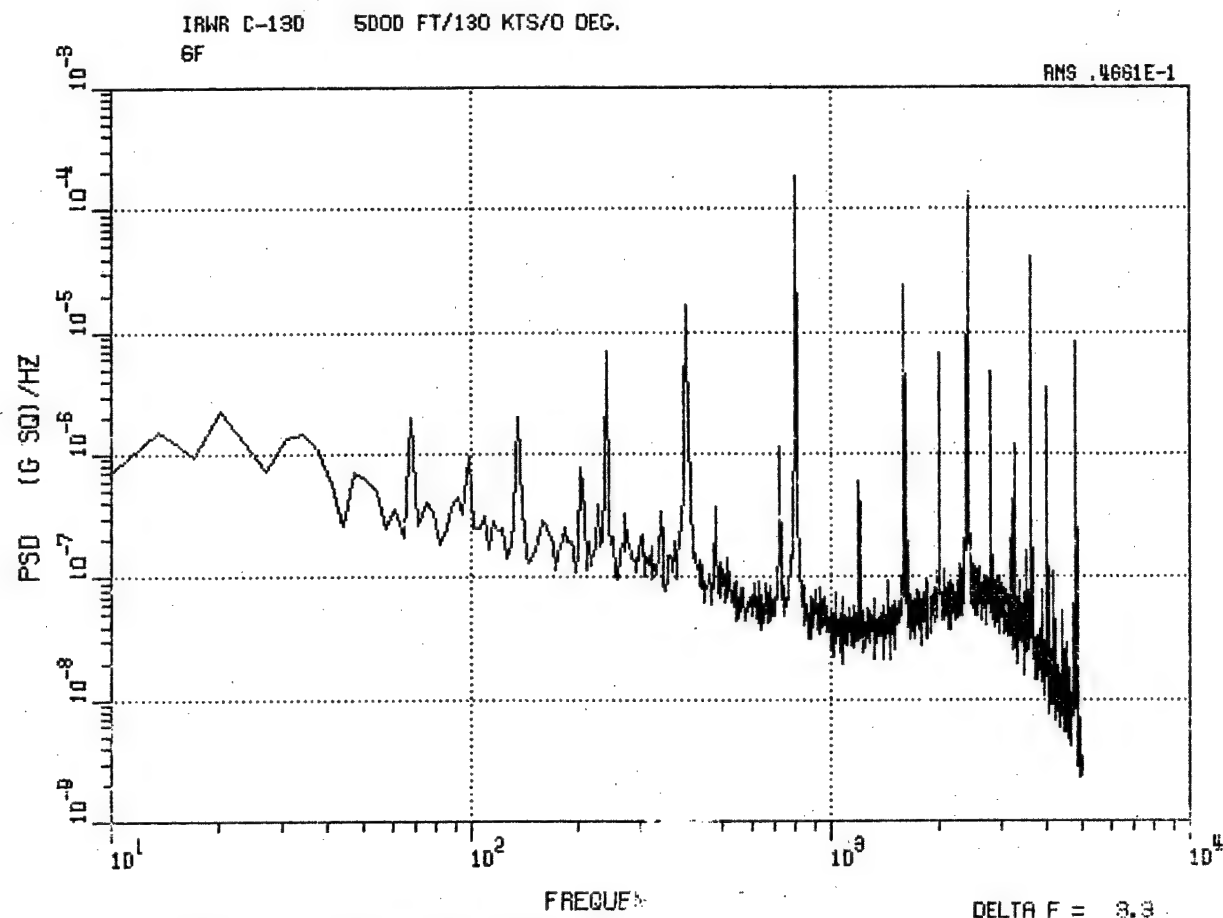
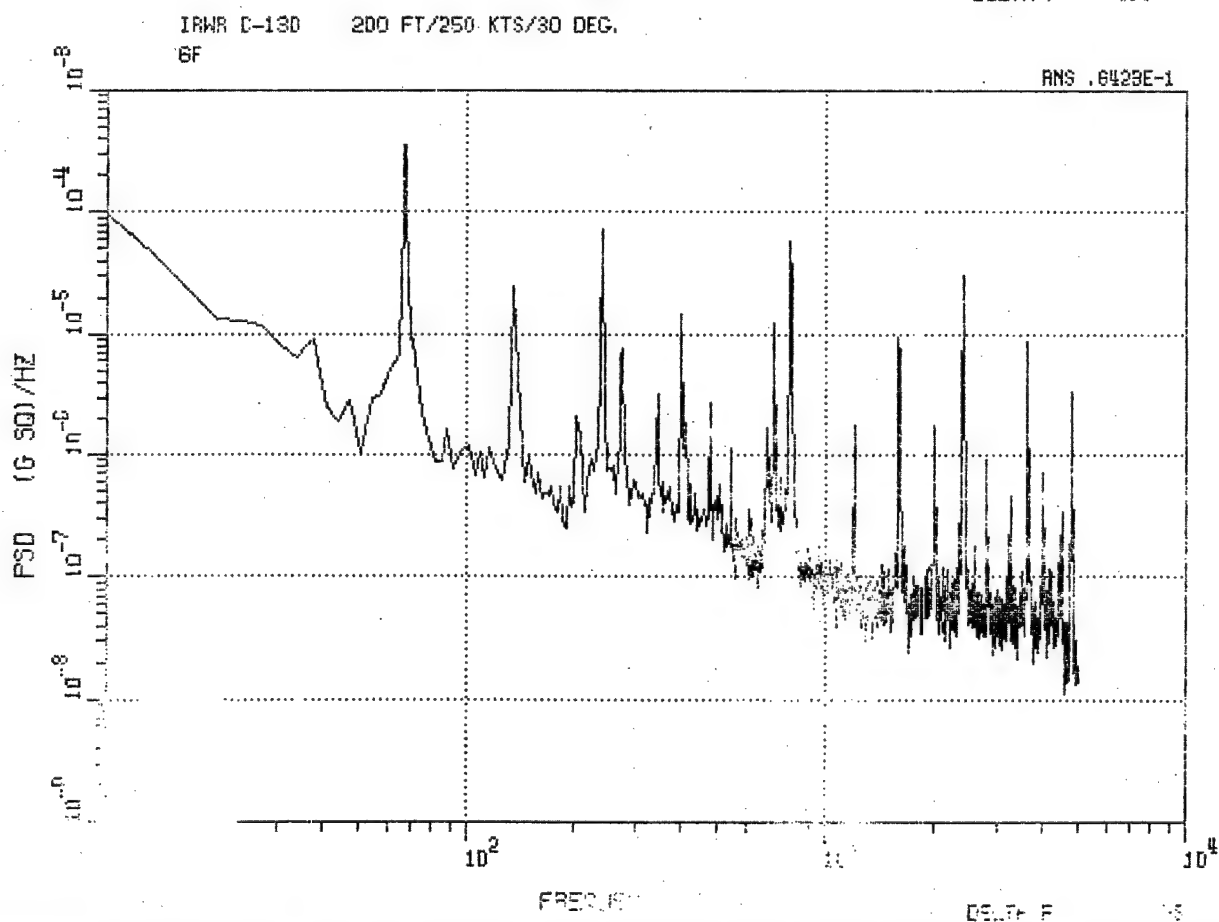
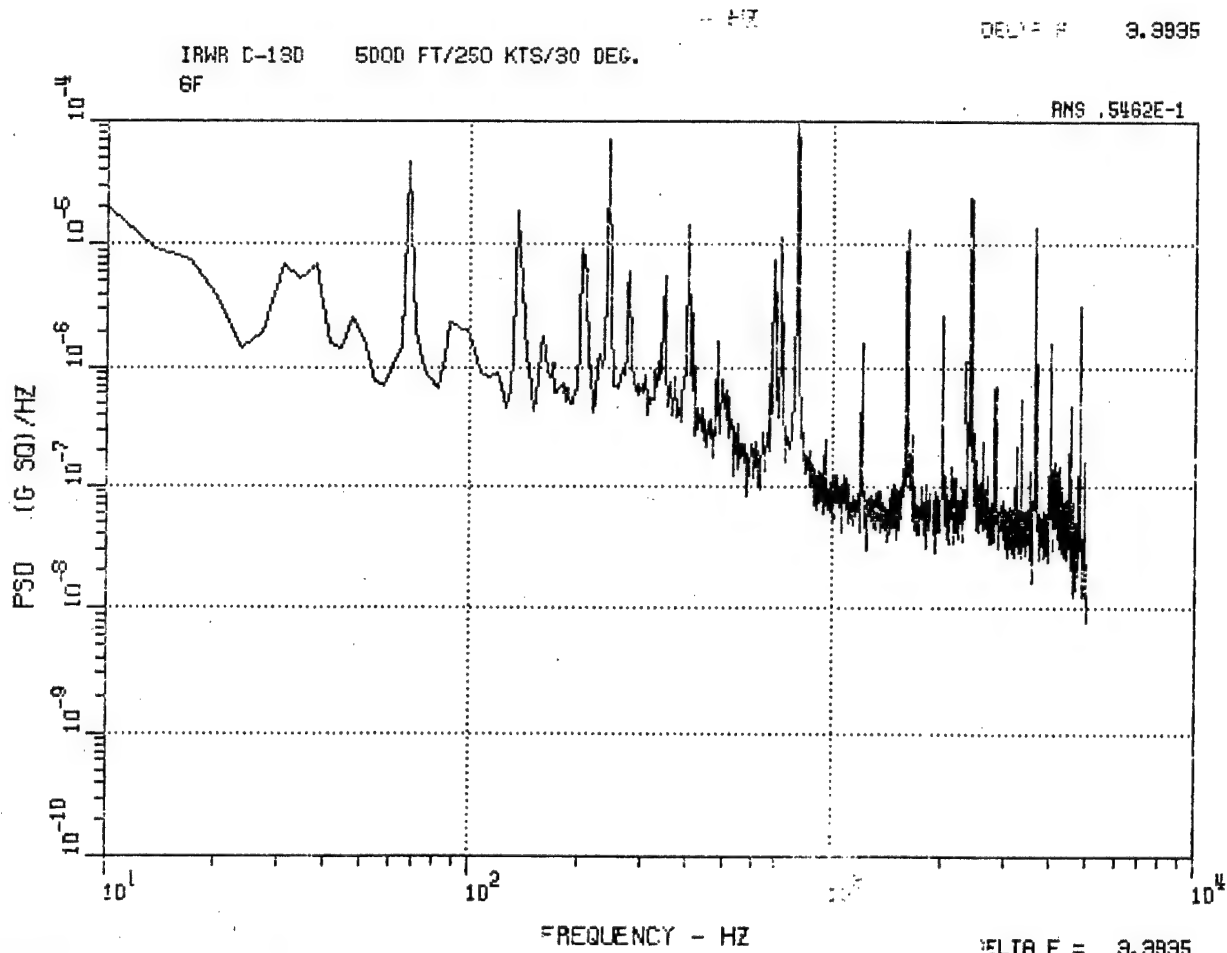
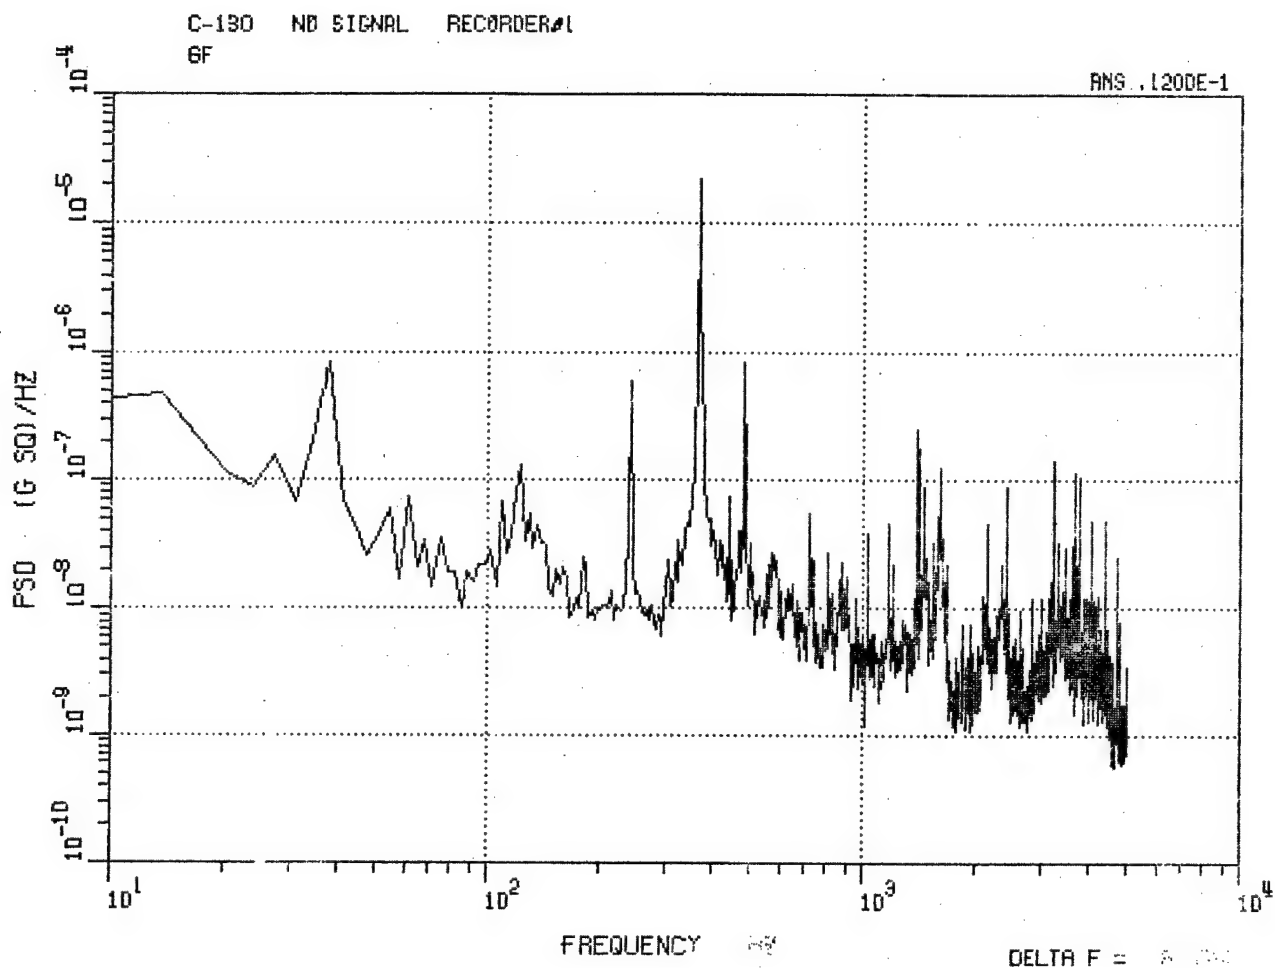
Figure 20. C-130 Fwd Longitudinal Accelerometer 6F, 200 Ft, 130 Kt, 0 Deg, and 1000 Ft, 130 Kt, 0 Deg.

Figure 21. C-130 Fwd Longitudinal Accelerometer 6F, 5000 Ft, 130 Kt, 0 Deg, and 200 Ft, 250 Kt, 30 Deg.

Figure 22. C-130 Fwd Longitudinal Accelerometer 6F, 1000 Ft, 250 Kt, 30 Deg, and 5000 Ft, 250 Kt, 30 Deg.

Figure 23. C-130 Fwd Longitudinal Accelerometer 6F,
No-Signal Record.
